Morphological Changes in Teesta River Basin: Impact and Adaptation Strategies in the Northern Bangladesh

PhD Dissertation

Department of Geography and Environmental Studies

University of Rajshahi, Rajshahi-6205, Bangladesh

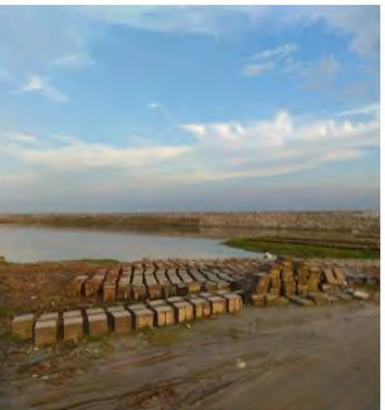
5. c) Teesta river revetment

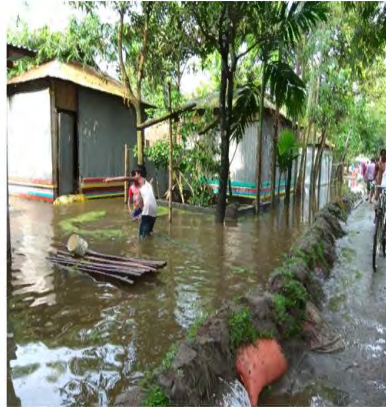
8. b) Artificial levee construction to prevent flood water

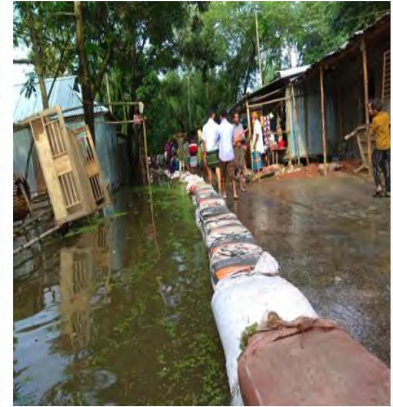
8. c) Sand bag piling for flood protection
